OMNI Series

AN EVERLAST™ EXCLUSIVE

OMNI SERIES

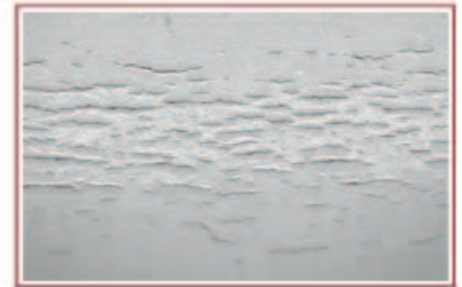
Overview of competitor panel magnified 30x

The photos above show how Everlast II's® OMNI Heat Formed™ panel outlasts the competitor's panel. The Heat Formed™ panel creates a paint system that is more flexible and therefore better able to withstand the rigors of the forming process. Paint coverage is not compromised and the result is outstanding barrier protection. This barrier protection prevents corrosion by isolating the steel from the environment.

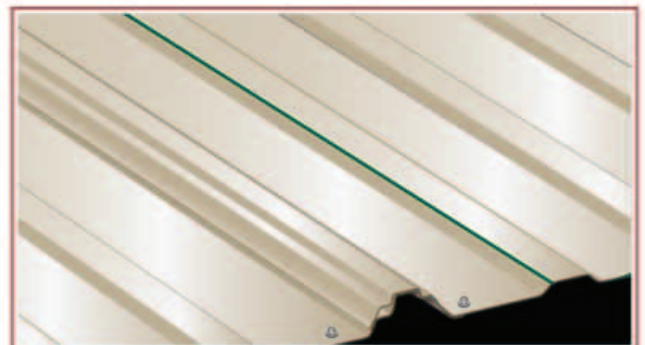
Photo micrographs taken from this area on the panel

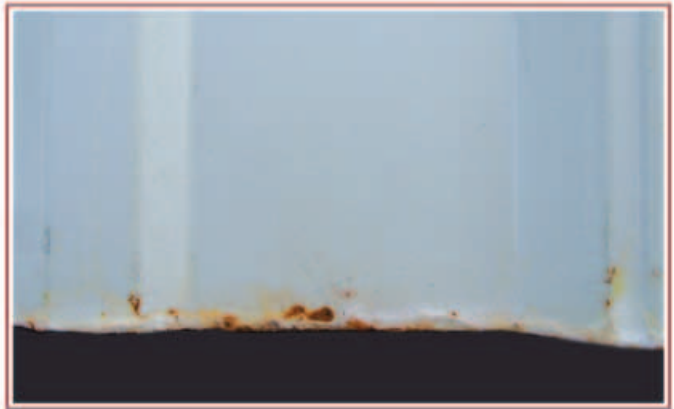
Overview of an Everlast II® panel without CECI™ exposed to 48 weeks of salt spray testing at 45° South Florida

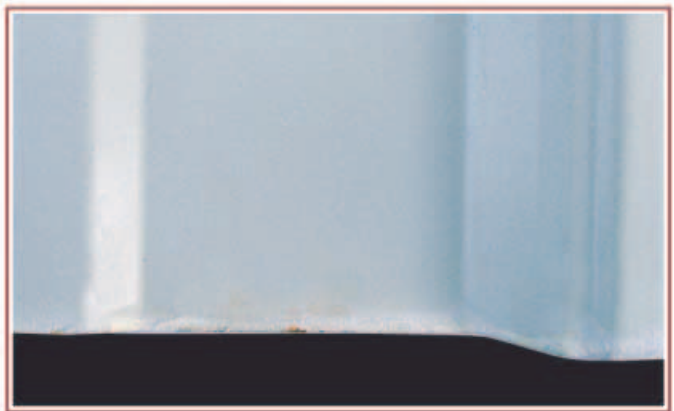
Overview of an Everlast II® panel with CECI™ exposed to 48 weeks of salt spray testing at 45° South Florida

CECI™ effectively decreases the corrosion rate of factory cut edge

Everlast's CECI™ (Cut-Edge Corrosion Inhibitor) effectively decreases the corrosion rate of the factory cut edge. This application is applied to the factory cut edge of all Everlast II's® OMNI Panels. Because the corrosion inhibitor applied is a clear product, end-users will see virtually no sign of CECI™ as it quietly protects and effectively decreases corrosion rates, as proven through industry research. The goal at Everlast Roofing is to incorporate cut-edge technological advances to our products, ensuring the highest standard of quality. CECI™ is another step in Everlast's commitment to bringing the metal marketplace the finest materials in quality building components.
