OMNI Series

AN EVERLAST™ EXCLUSIVE

Cross section view of Everlast II® panel

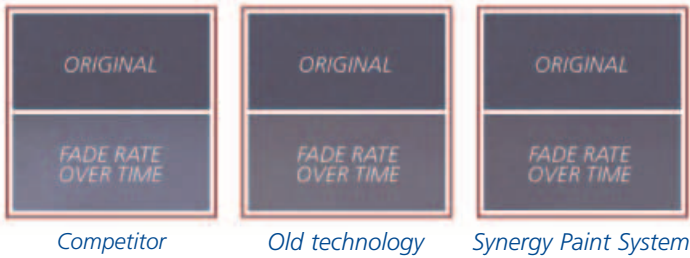
FADE RATE: LOWER IS BETTER

A gradual change in the panel's paint color or gloss is known as fading. Fading occurs when there is a breakdown in the pigment caused by direct panel exposure to the sun's UV rays.

0	5	10	15	20	25	30	35	YEARS
SYNERGY PAINT SYSTEM	0	1	1.5	2	3	4	4.5	5	
OLD TECHNOLOGY	0	2	3	4	5	6	7	8	
COMPETITOR	0	3	4	6	9	11	13	14
